Improving Structural Stability: Non-Destructive Evaluation in Building Maintenance

Structural Audit Report for old staff quarter residential building of class - iv, old residential Building No. 06, at MSEDCL, Jalgaon.

Structural audit & present condition of Shahu Maharaj Civil Hospital, Near Mahanagar Palika/Nutan Maratha Mahavidyalaya, Jalgaon, Maharashtra, India.

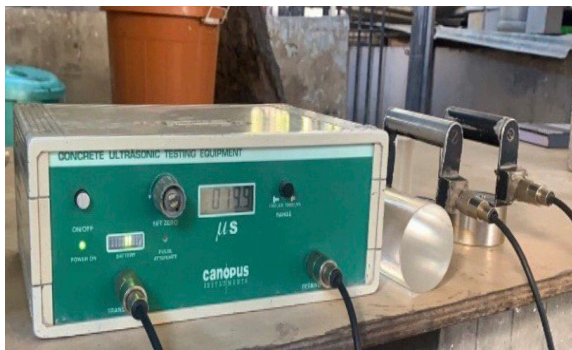
Fig. 3. Ultrasonic pulse velocity instrument

information is required. The usefulness of this instrument is unexpected upon the Energetic Young's Modulus, thickness, and Poisson's proportion of the fabric in utilize. To degree the time taken for travel, the transducers are situated on a smooth concrete surface. A coupling medium, such as petroleum jam or oil, is connected over the surface to guarantee viable acoustical coupling. The speed is at that point computed utilizing the equation $v=L/T$, where 'L' speaks to the remove between two tests, and 'T' is the time taken for the flag to travel this remove between the transducers as appeared in Fig. 3 and Fig. 4.

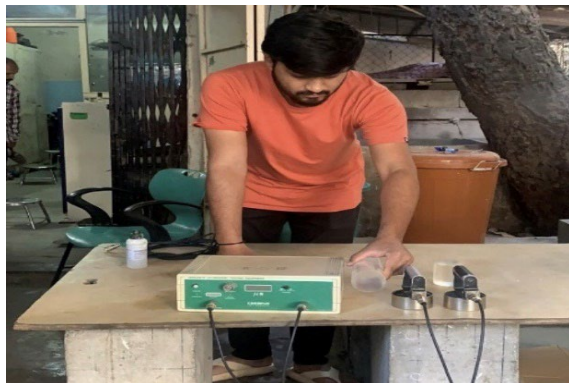
Fig. 4. Checking connectivity of UPV

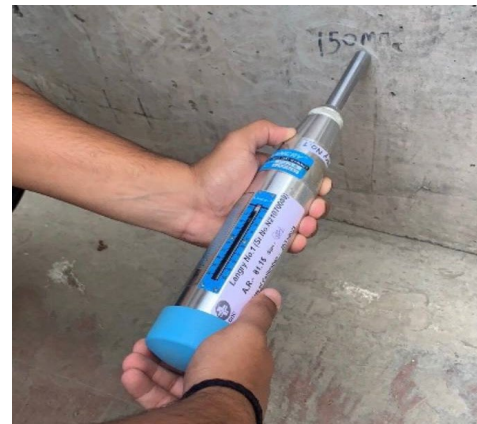
Fig. 5. Rebound hammer

The Rebound Hammer method operates on the principle that the rebound of a spring-loaded mass is affected by the hardness of the surface it strikes. To conduct the test, the hammer's plunger is firmly pressed against the concrete surface, perpendicular to it, until the mass is released from its locked position. Before starting the test, it's crucial to ensure the reliability of the rebound hammer by checking it against a designated anvil. This anvil should be made of steel with a Brinell hardness number of around 5000 N/mm². The test can be performed horizontally on a vertical surface or vertically in

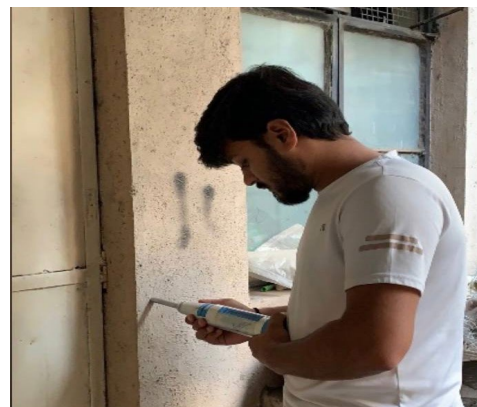
Fig. 6. Working of rebound hammer

an upward or downward direction on horizontal surfaces. After the hammer strikes the surface, the rebound number is measured as a percentage of the distance traveled by the mass. This rebound velocity is then compared with a calibration graph to determine the compressive strength of the concrete.

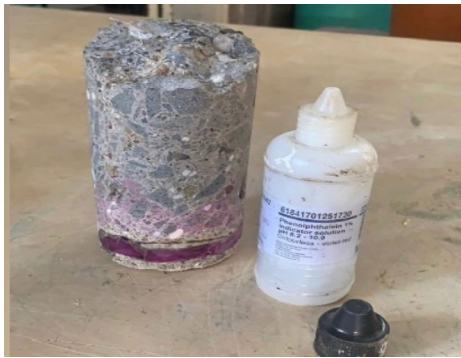
Fig. 7. Carbonation test

The purpose of the carbonation test is to evaluate whether the concrete cover provides adequate protection to the steel reinforcement against corrosion in the presence of both oxygen and moisture. Following the procedure outlined in ASTM C876-15: Corrosion potential of uncoated reinforcing steel in concrete, phenolphthalein indicator is applied to the surface of cylindrical cores immediately after extraction. This application allows for the measurement of the depth of carbonation within the concrete.

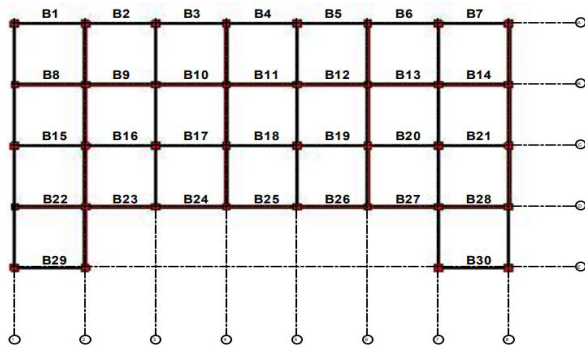
Fig. 14. Plan showing beam details

Fig. 14. Shows beam position. Also, as per Table 1 and Table 2, quality remarks are marked.

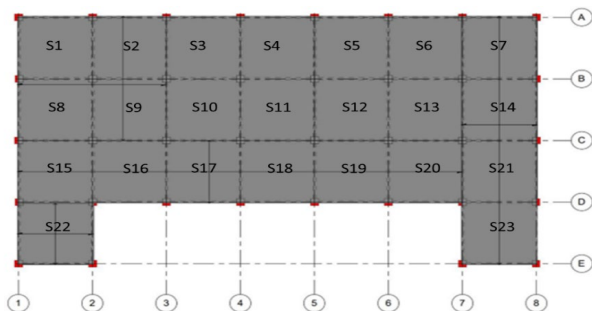
Fig. 15. Plan showing slab details

Fig. 15. shows slab position. Also, as per Table 1 and Table 2, quality remarks are marked.
